## LOCK AND DAM NO. 4 RED RIVER WATERWAY, LOUISIANA

### FOUNDATION REPORT

#### CONSTRUCTION FOUNDATION REPORT LOCK AND DAM NO. 4

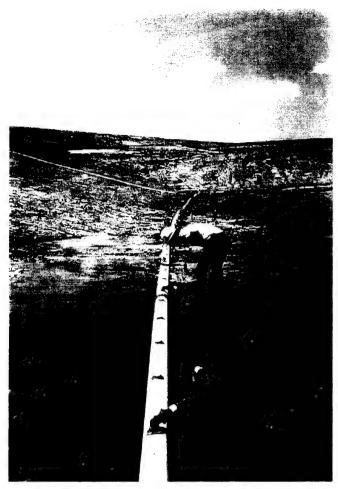
25. Wellpoint system used to lower Tertiary hydrostatic pressures for the gated dam excavation.

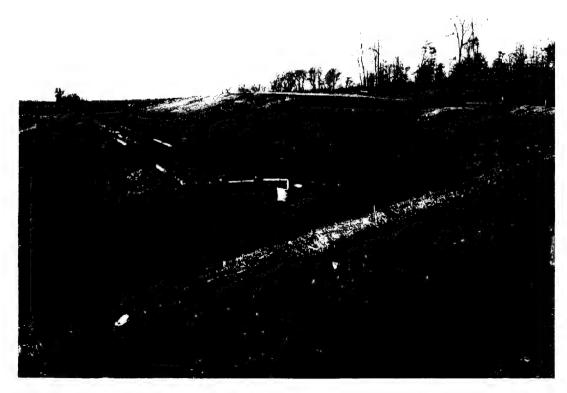
26. Temporary collector disches and sump to dispose of surface water.

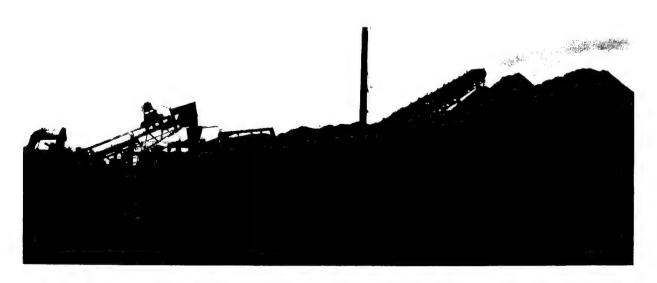
23. Processing select sand from dredged sand.

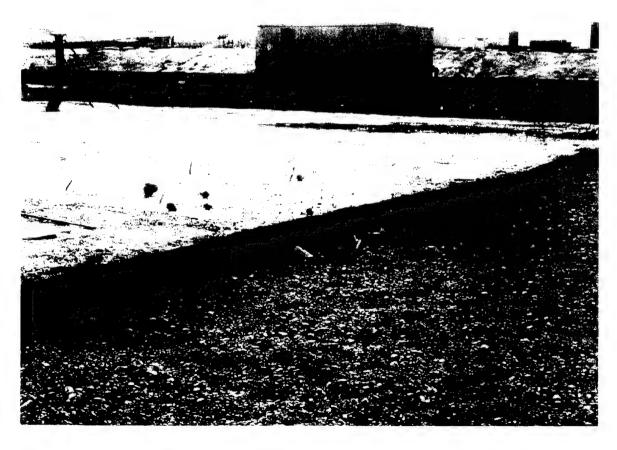
30. Filter gravel "C" beneath gated dam. Note stabilization slab.

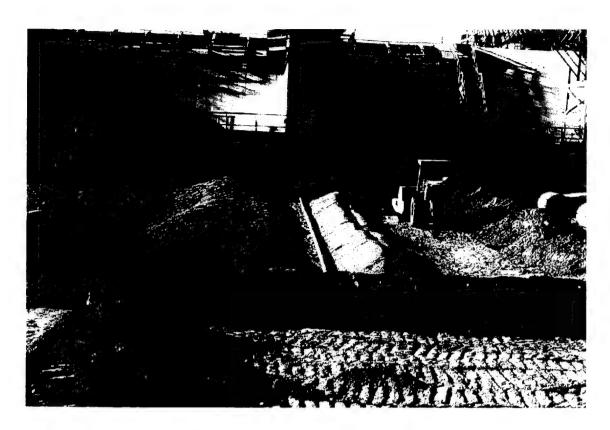
33. Installation of the stainless steel collector system beneath the stilling basin.

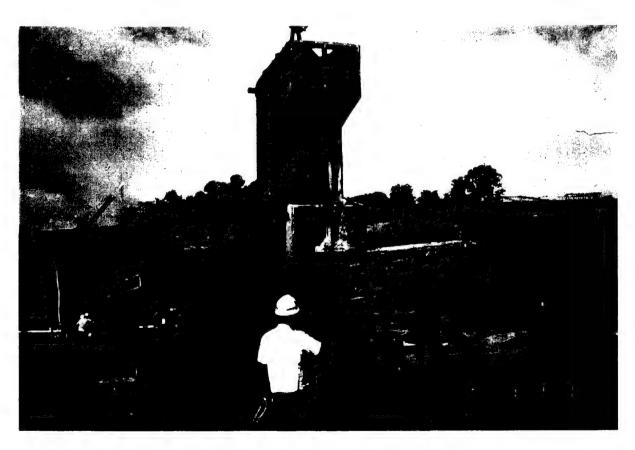
36. Installation of sheet pile in the foundation for the gailed days.

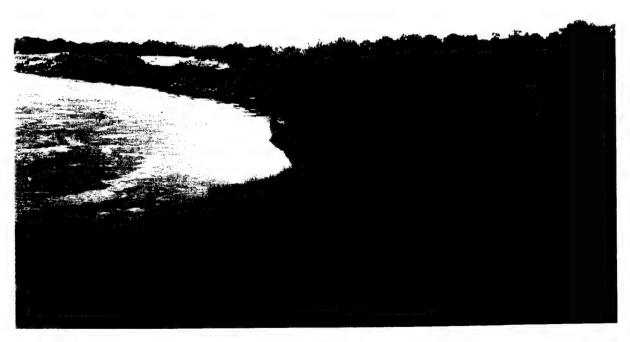
42. Tension cracks preceding bank caving, upstream access channel.
